THE NORFOLK RIVERS TRUST
RESTORING NORFOLK'S RIVERS

THE RIVER HEACHAM

A WATER FRAMEWORK DIRECTIVE LOCAL CATCHMENT PLAN

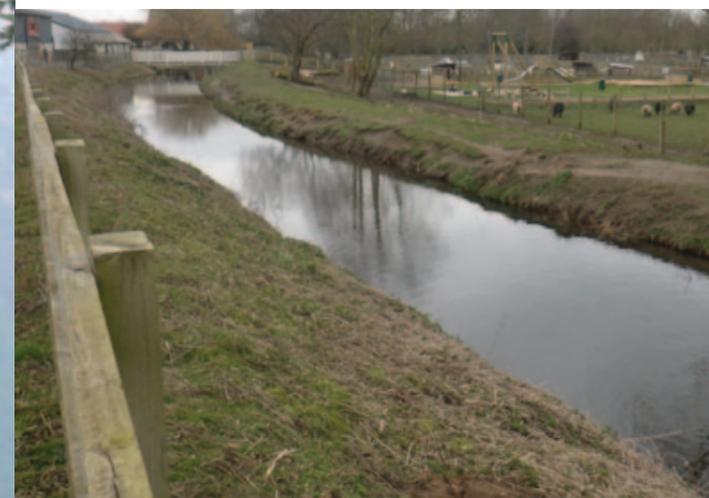
Before restoration work.

Cooperation from landowners and support from volunteers have been vital in the first projects which we have undertaken on the Heacham, such as the work at Heacham Lavender which was underway in March 2014.

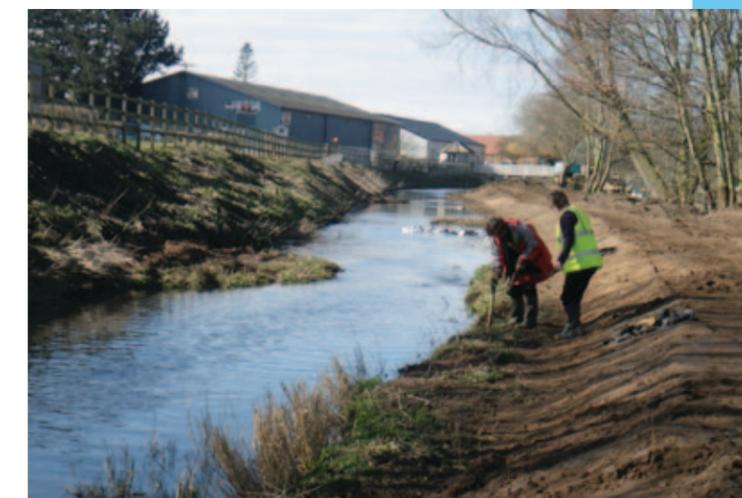
Immediately after restoration work.

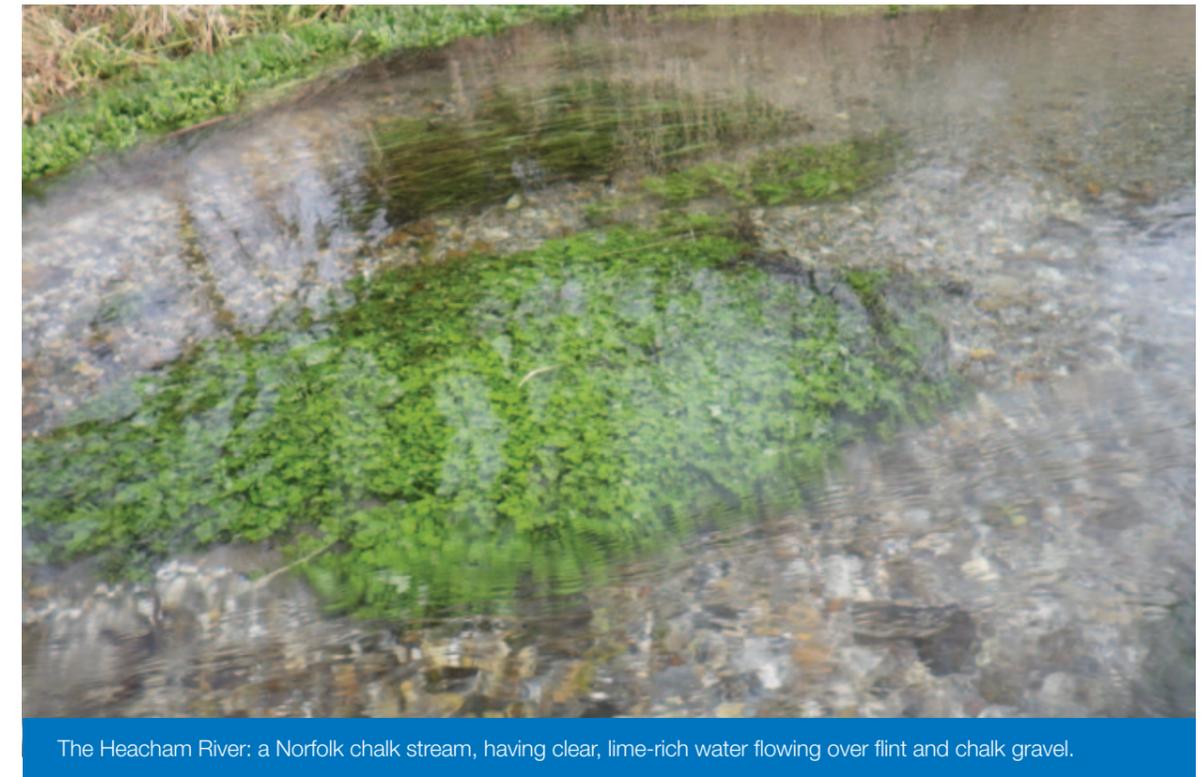
The Heacham River: a Norfolk chalk stream, having clear, lime-rich water flowing over flint and chalk gravel.

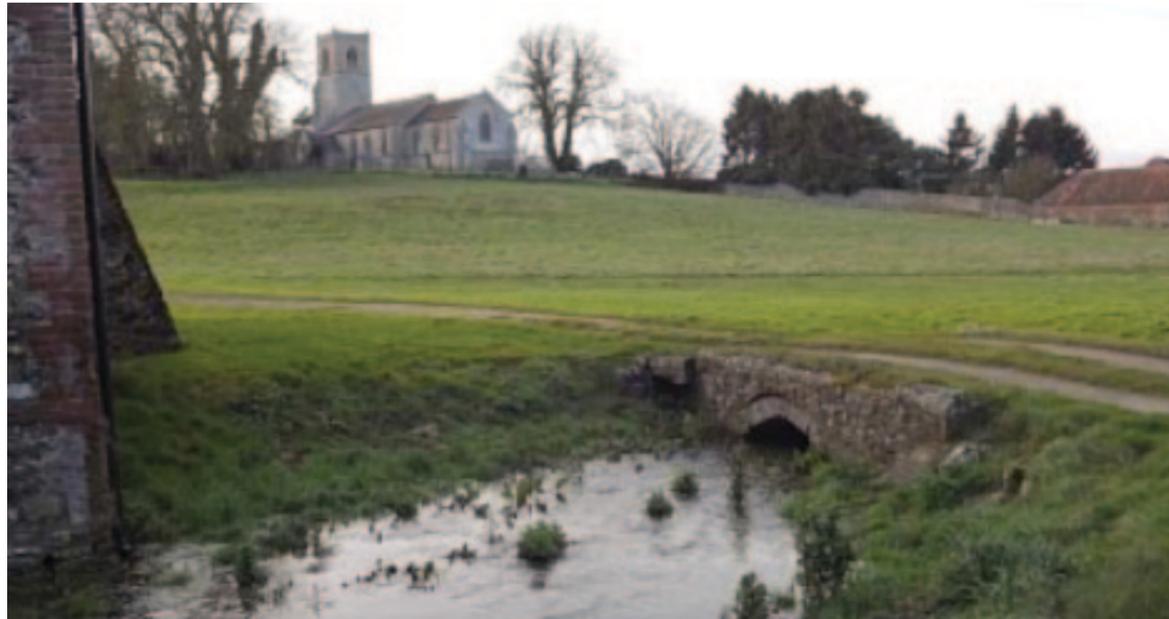
A winterbourne flowing strongly at Church Farm, Fring, in February 2014. Downstream, the water vanished into the ground after a distance of some 500 m (546 yds).

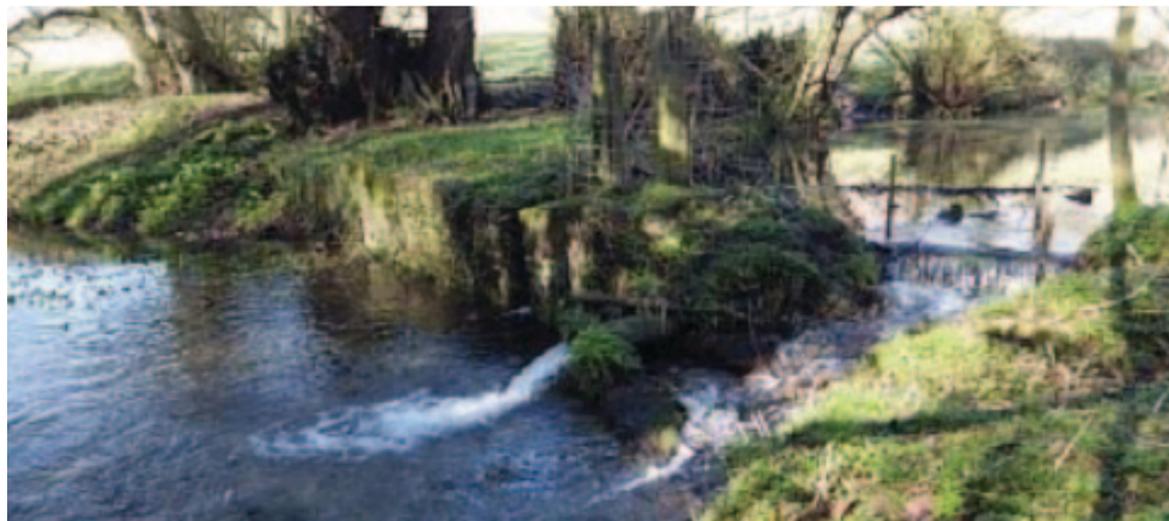
St Mary's Well at Sedgeford is a permanent spring feeding the river with chalk-rich groundwater. Seen here flowing strongly, February 2014.

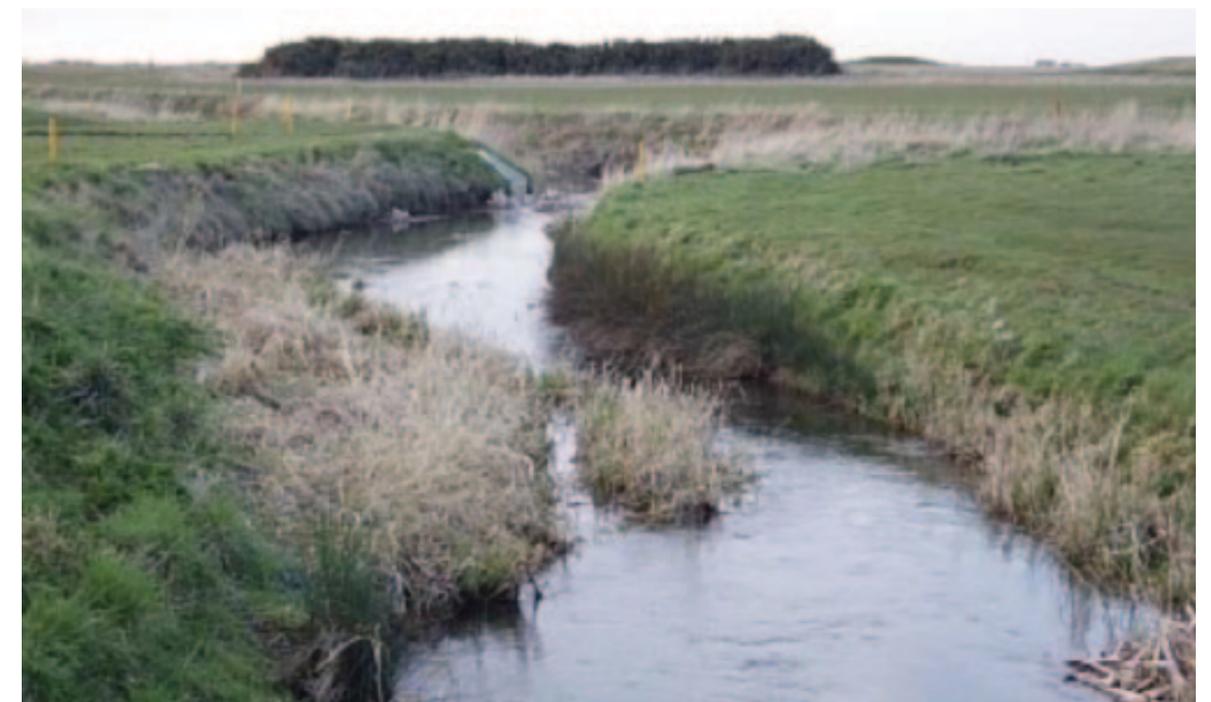
The river is channelled where it passes through Heacham golf course, and has lost natural connection with its floodplain.

horizon. The river slows markedly as it enters the flatlands near Heacham golf course, where it becomes canalised and its bed is dominated by sand and silt. It flows westwards over a bed of thick alluvial soils developed on reclaimed saltmarshes, then turns southwards as a straight marsh drain beside the 19th century sea wall. It flows under the wall at Kalla Jugga sluice, and continues southwards confined between the barrier beach and reclaimed marshes for 1 km (0.6 miles) as far as South Beach Road. Here, the water is discharged through a sluice into The Wash by gravity at low tide; the sluice prevents the lowest reaches of the river from becoming salinated, but may impede the passage of migratory fish.

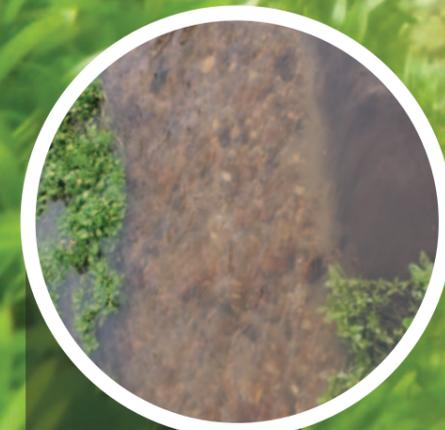
Water plants cause flow variation which also encourages sediment storage and scour.

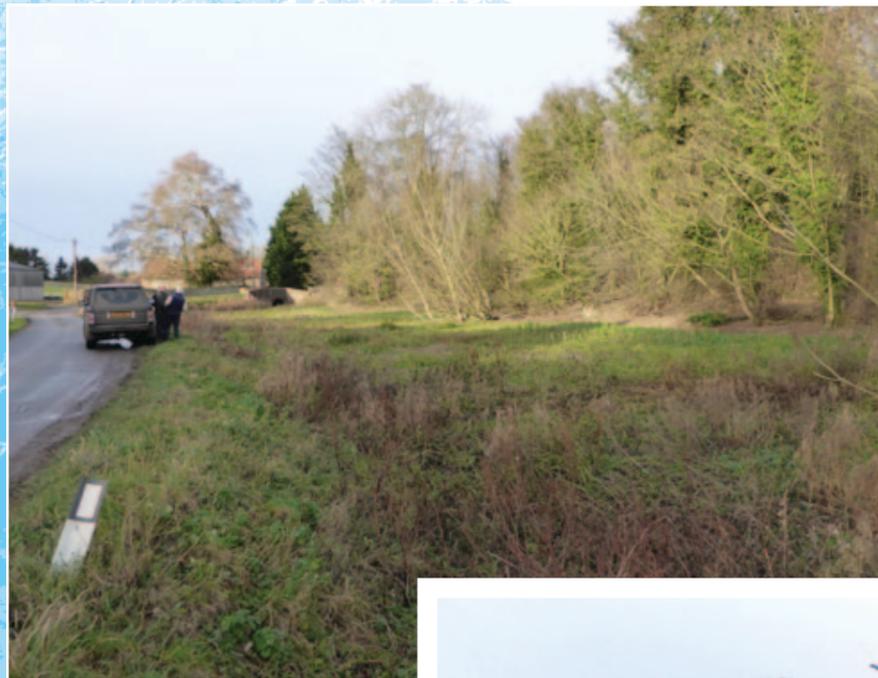
Photo 1. A pond in Fring which is periodically filled by water from the Heacham, but which is currently dry (autumn 2013). It is called “Fring Harbour” by some locals due to historical accounts that small barges once navigated the river Heacham up until this point.

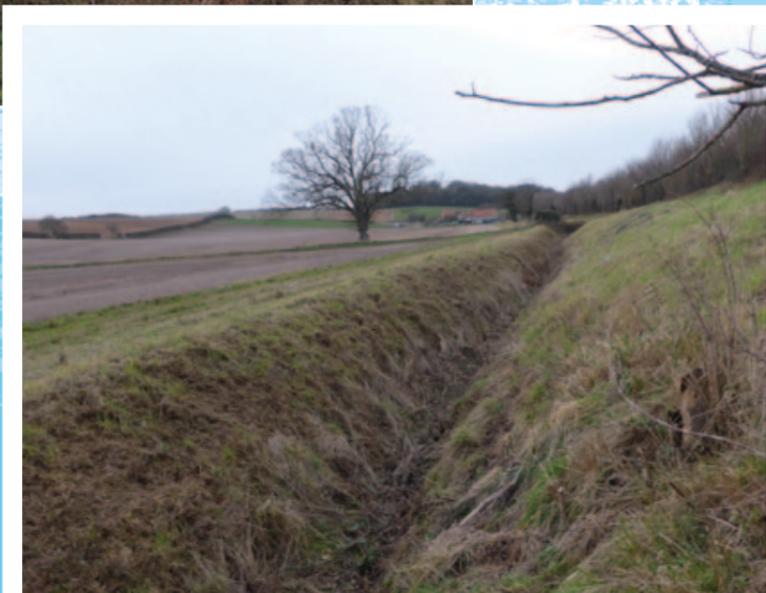
Photo 2. Dry section of stream in winterborne section of Heacham.

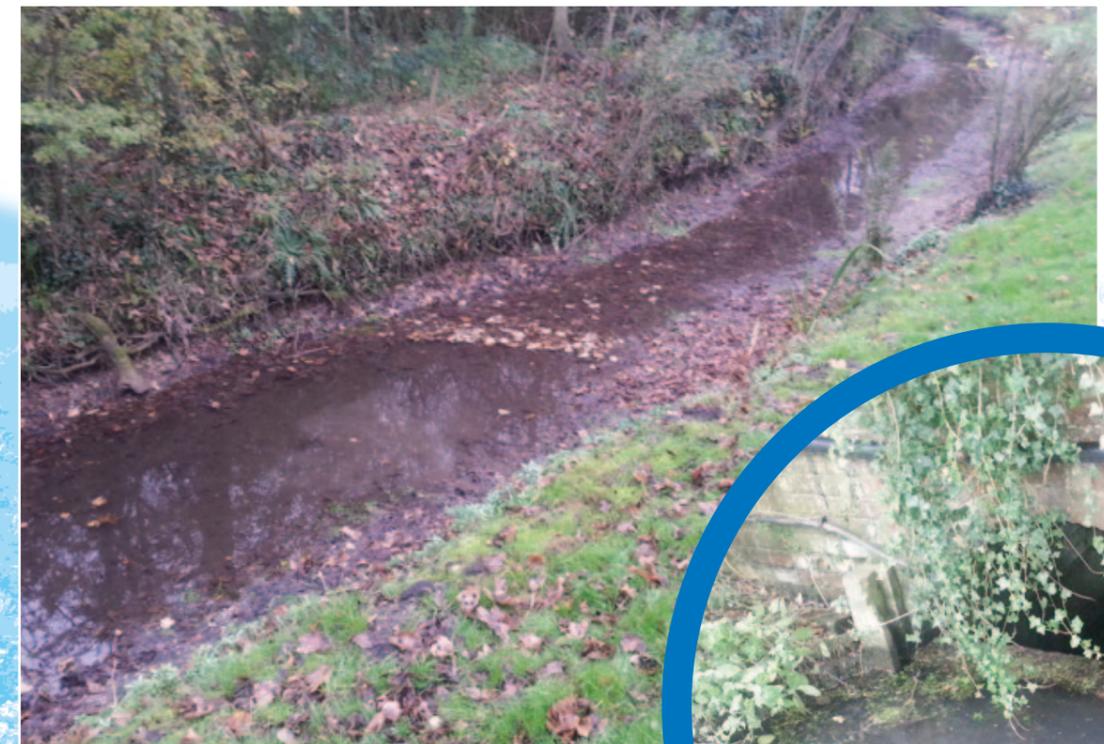
Photo 3. Start of permanently wet section of River Heacham in Sedgeford.

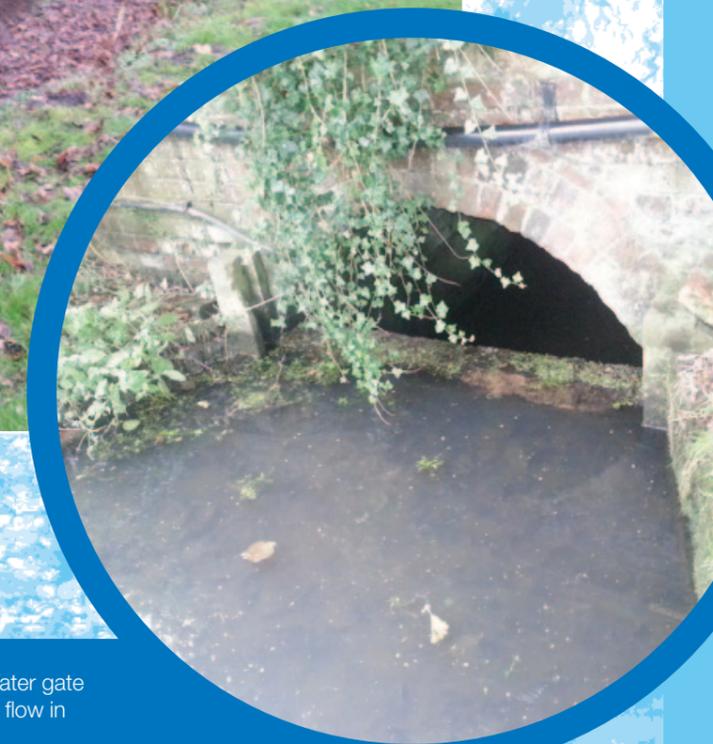
Photo 4. Water gate impounding flow in Sedgeford.

Within Sedgeford itself, the bed of the River Heacham usually contains water, but often has a very slow flow and is more similar to a long ditch or pool during periods of moderate water levels. It is impounded by a “water gate” in the village, which further reduces flow speeds and causes sediment accumulation behind it (Photo 4).

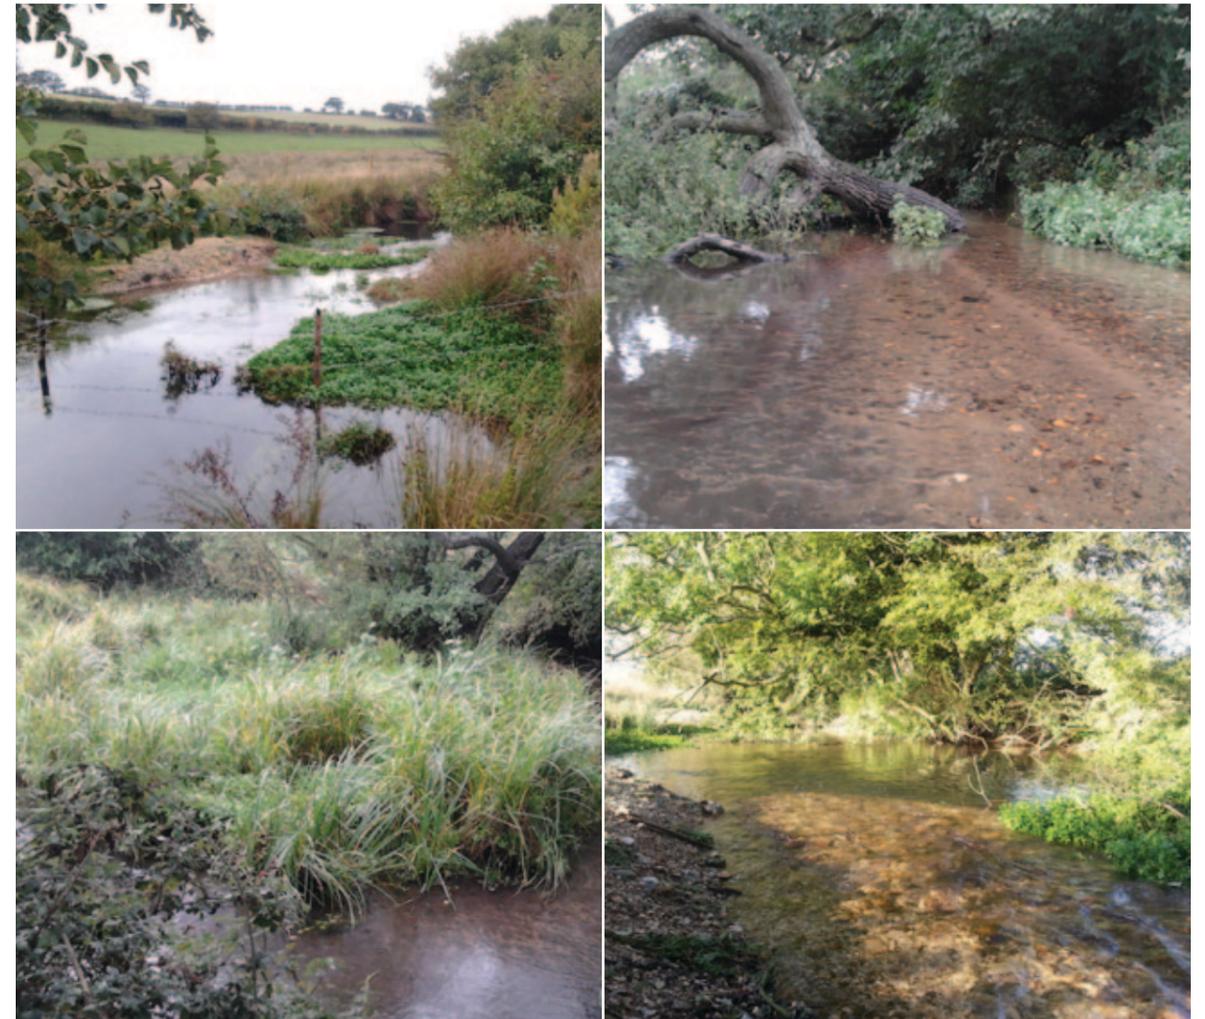
River restoration and fencing of livestock has reinstated a variety of river habitat at Eaton Farm.

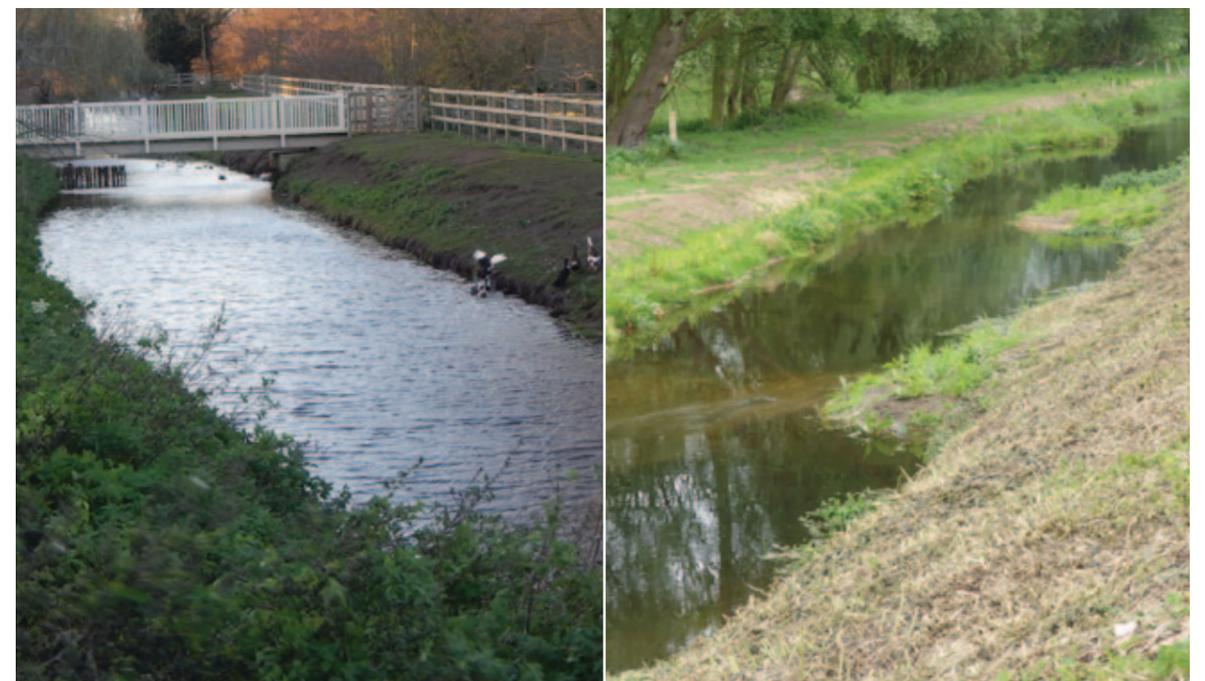
Lavender mill pond before and after March 2014 habitat enhancement.

At Norfolk Lavender the river is impounded and backs up into slow moving water in an until-recently straight-sided and featureless channel. This is a rare point where the public can view the river, and recently completed rehabilitation works on this section should greatly improve people's enjoyment of the area.

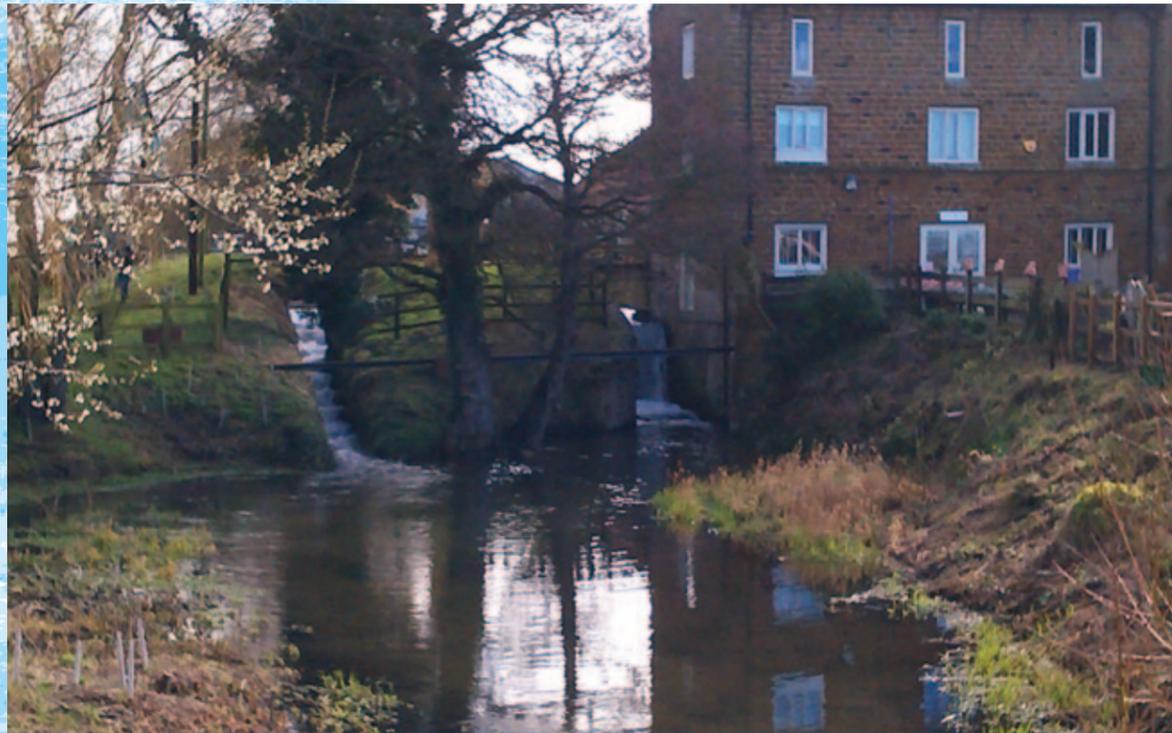
Heacham Lavender Mill. A beautiful building, but also a barrier to fish passage.

completed work at this site should serve to improve this situation. The mill’s weir itself is a barrier to fish and this could be modified to allow fish passage in the future.

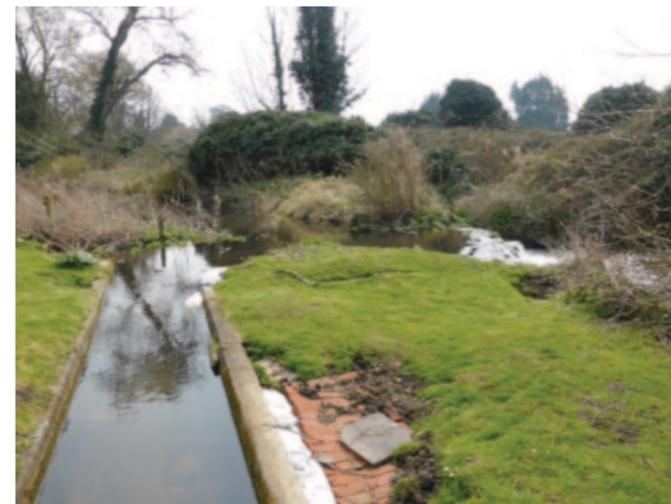
Impoundment near Pocahontas Lake, Heacham. Channel flowing towards photo flows through the fishing lake and then back into the river. The impoundment will prevent course fish passage, and would be a barrier to migratory species under most flow conditions

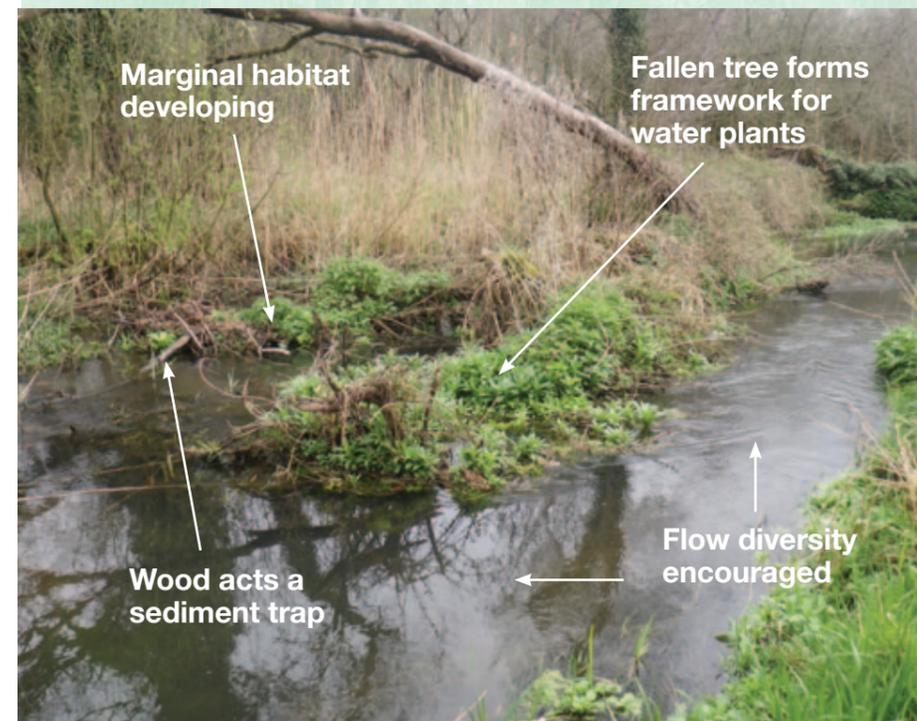
Growing trees have changed this former straightened drainage channel into a river with a more natural structure and in-stream islands (anastomosing channel).

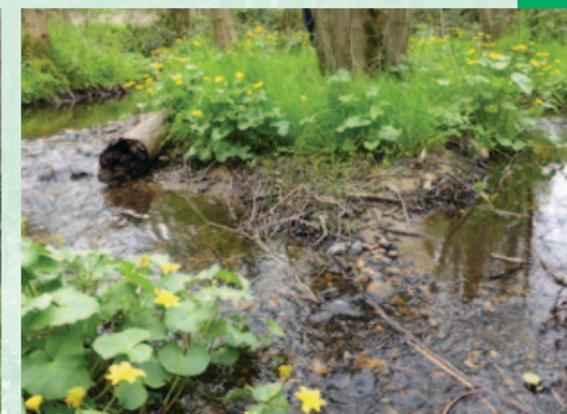
Tree acts as a hard point and has caused a meander to develop.

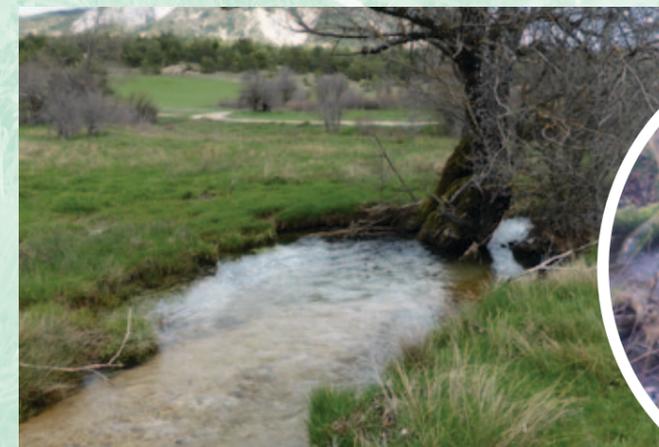
Natural tree fall has caused a great range of microhabitats and greatly increased in-stream surface area for a diversity of river invertebrates.
