THE NORFOLK RIVERS TRUST
RESTORING NORFOLK'S RIVERS

THE RIVER MUN (OR MUNDESLEY BECK)

A WATER FRAMEWORK DIRECTIVE LOCAL CATCHMENT PLAN

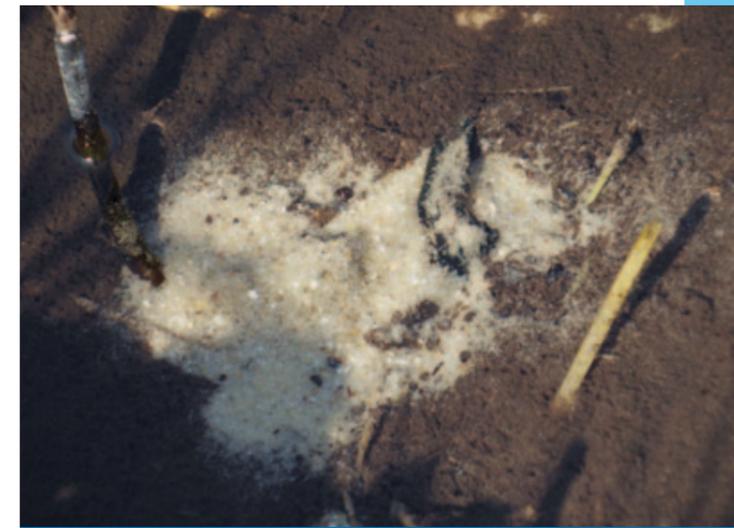
A boiling spring in the river bed near Frogshall Bridge, March 2014.

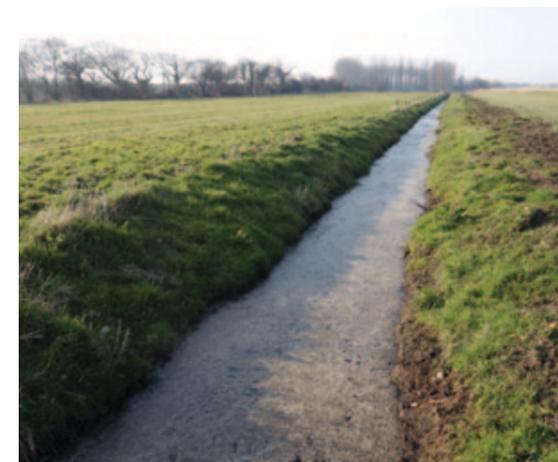
The River Mun at Gimingham Hall Farm. It is now a drainage canal and has lost a formative relationship with its floodplain.

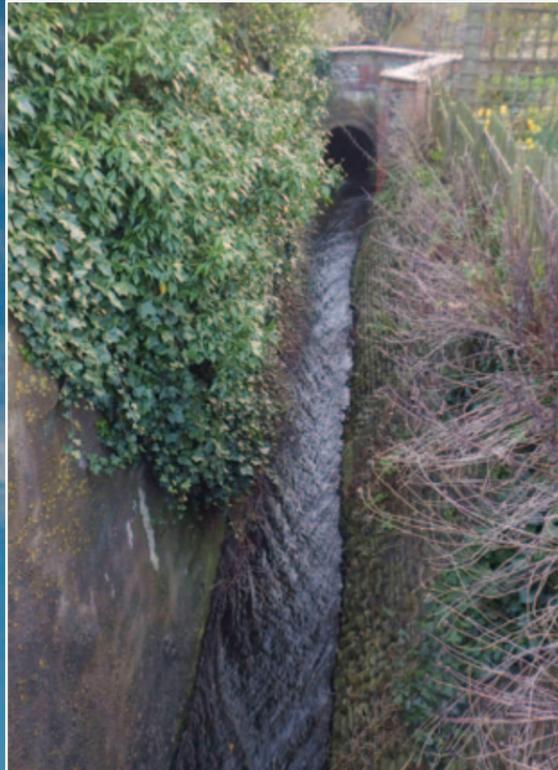
The waters of the River Mun are channelled through a steeply inclined concrete spillway as they pass under Paston Road.

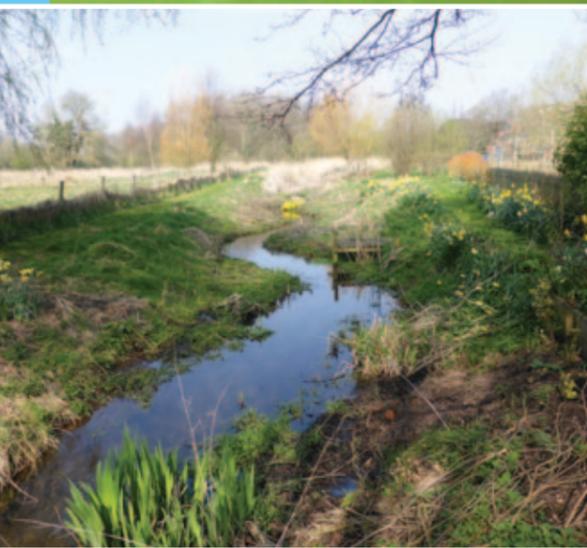
Ten years ago this section of stream was absolutely straight and featureless. Growth of plants and sediment deposition around dead plants has caused a return to a more natural meandering form, which in turn has started to cause pools and riffles to develop. (Photo: Olly van Biervliet, Fox's Beck, Norfolk. With thanks to John Dowland)

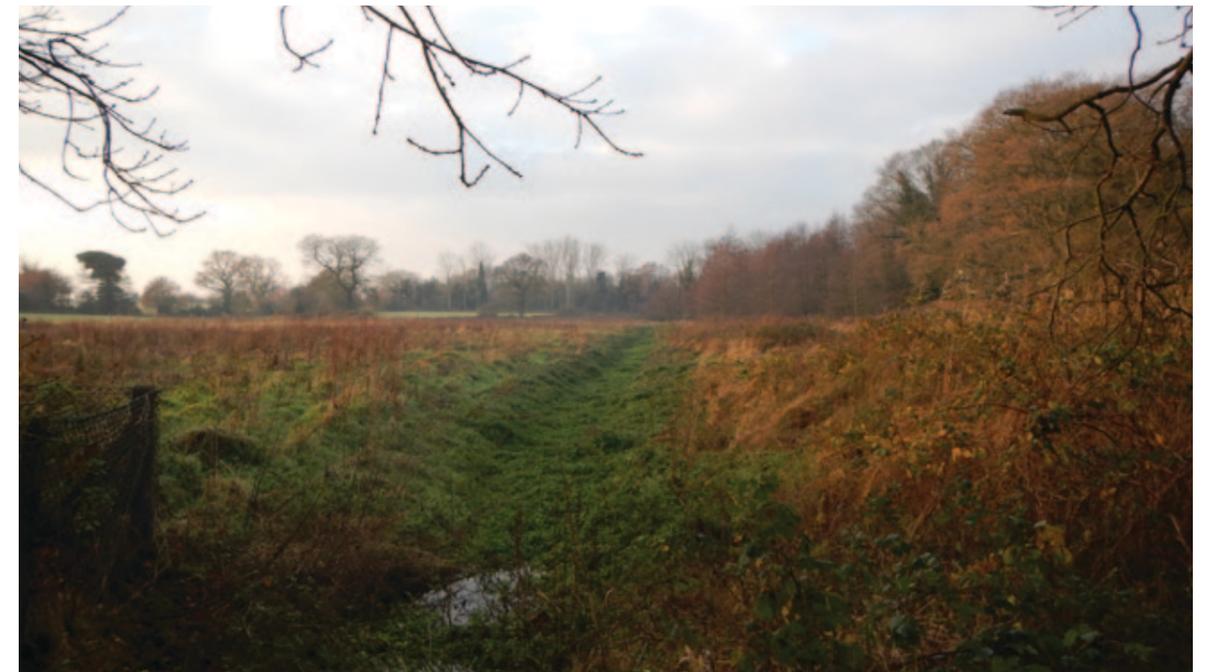
Photo 2. River Mun flowing through abundant fool's watercress (a water plant) growth, which almost completely obscures the channel. The vigour of this growth is symptomatic of the very high nutrient levels at this point.

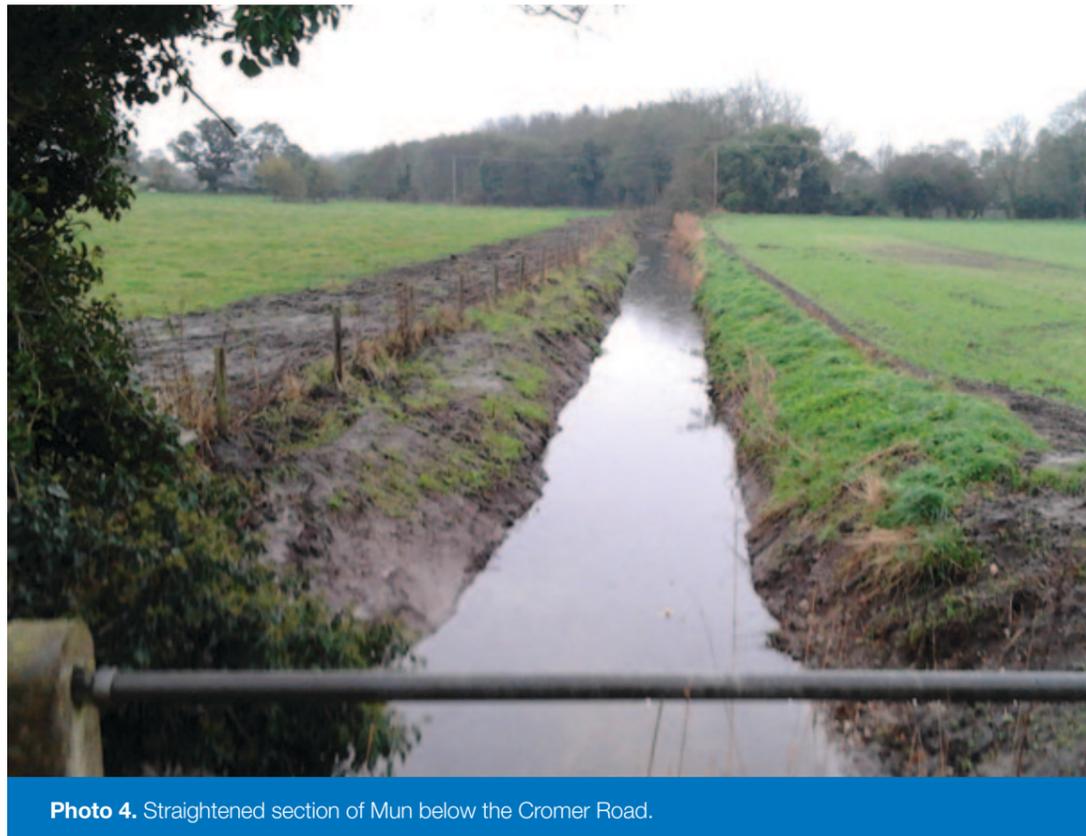
Photo 4. Straightened section of Mun below the Cromer Road.

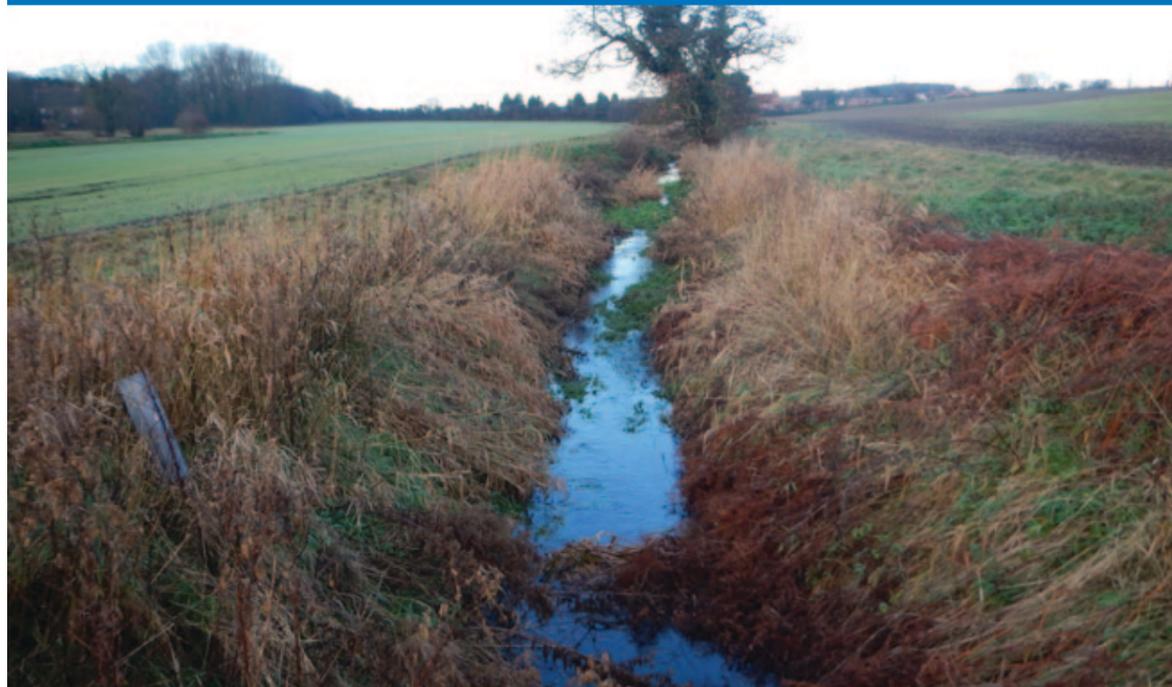
Photo 10. Sluggish channel with insufficient velocity to prevent emergent water plants from establishing themselves across the channel.

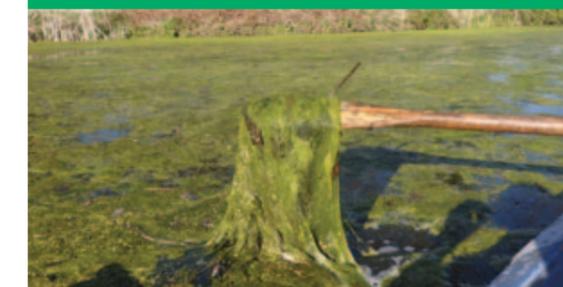
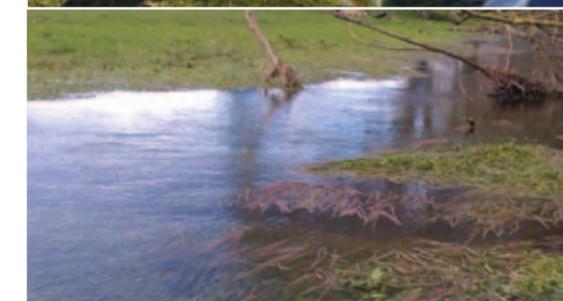
Algal mats and duckweed start to grow in March and will build throughout the season until they smother the lake, removing oxygen as they rot.

Diverse water plant growth on the upper River Leach facilitated by good water quality.

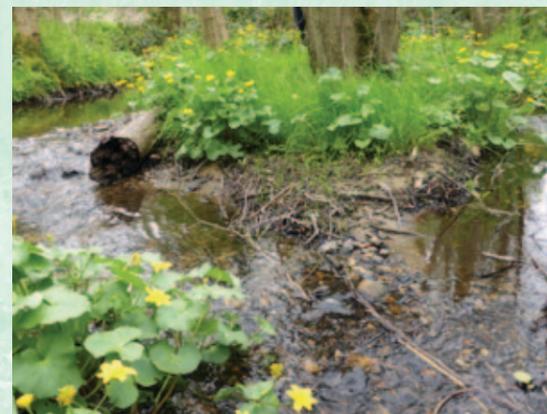
Growing trees have changed this former straightened drainage channel into a river with a more natural structure and in-stream islands (anastomosing channel).

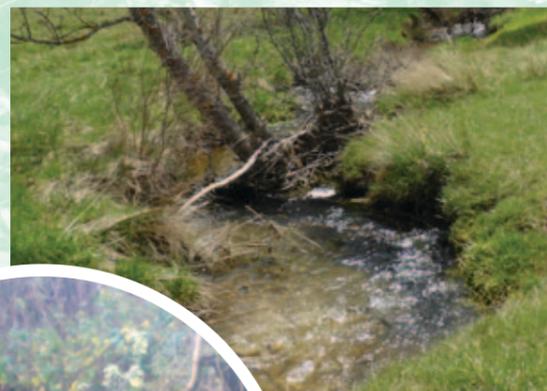
Tree acts as a hard point and has caused a meander to develop.

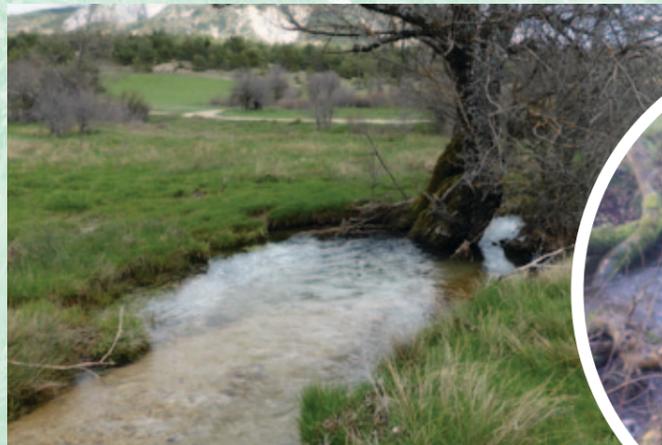
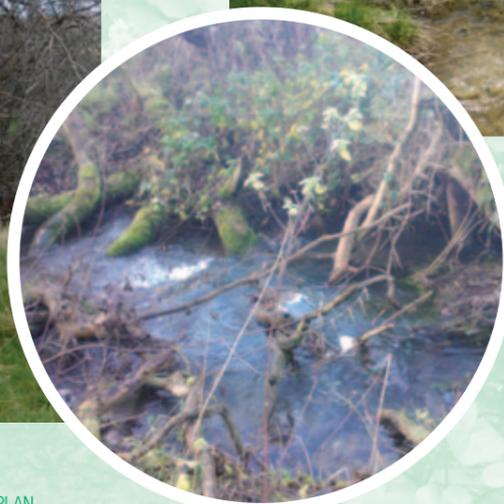
Tree acts as a hard point and has caused the development of a pool. Submerged tree roots are also excellent habitat for brown trout.

Natural tree fall has caused a great range of microhabitats and greatly increased in-stream surface area for a diversity of river invertebrates.
