THE NORFOLK RIVERS TRUST
RESTORING NORFOLK'S RIVERS

THE RIVER NAR

A WATER FRAMEWORK DIRECTIVE LOCAL CATCHMENT PLAN

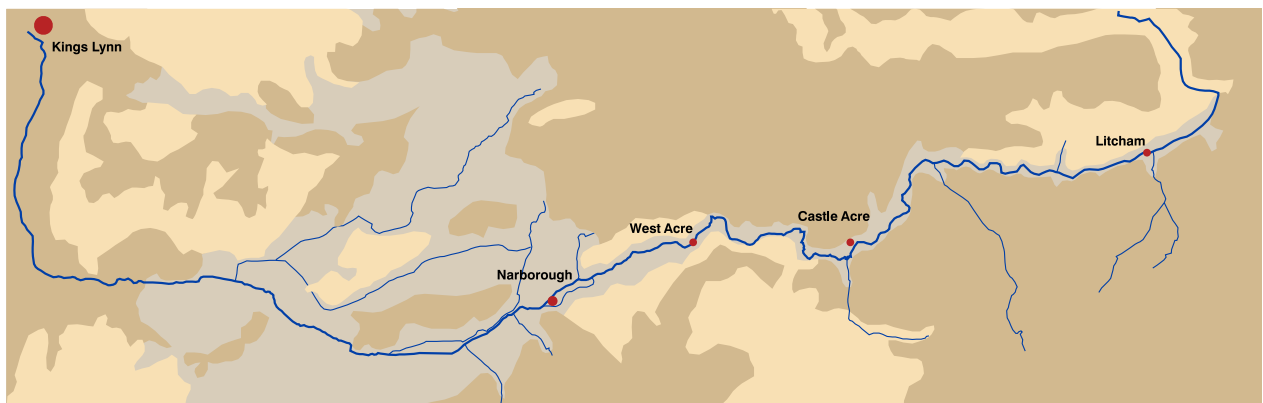
SOIL TYPES AROUND THE RIVER NAR

SANDY SOIL
 LOAMY SOIL
 PEATY SOIL

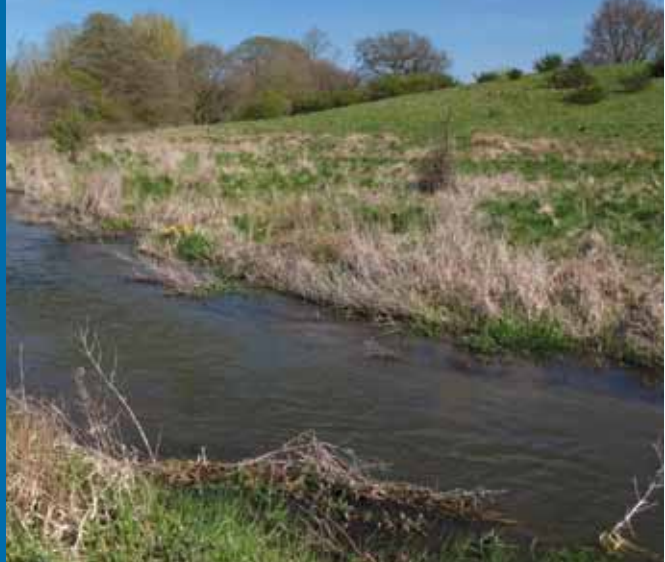
R-13 **GB105033047791**

Morphology – **supports good.**

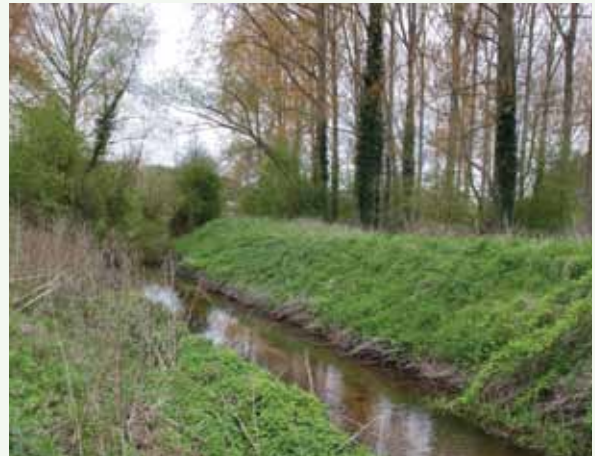
CANALISATION and DREDGING creates a river that is isolated from its riparian fringes and floodplain: a low-energy, spring-fed stream flowing through an incised trench is unable to function as a river and the whole river's ecology suffers.

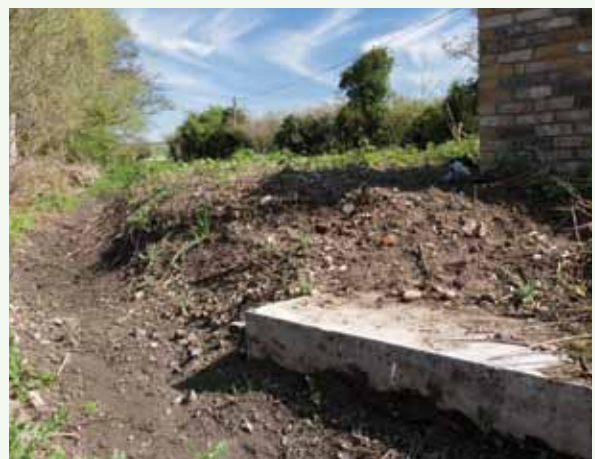
SEDIMENT POLLUTION which washes off farmland, hard-stands, tracks and roadside verges flows into the river through a network of drains and ditches.

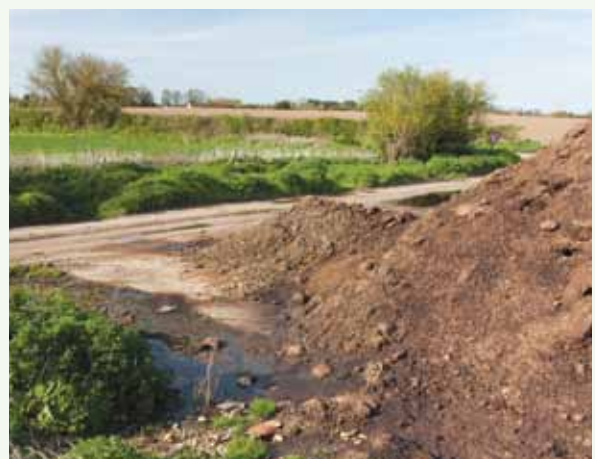
POOR AGRICULTURAL PRACTICES. This pile of manure was left on a hard-standing beside the river (April 2012) and its effluent was leaching across the road, into a ditch, through a culvert and into the river.

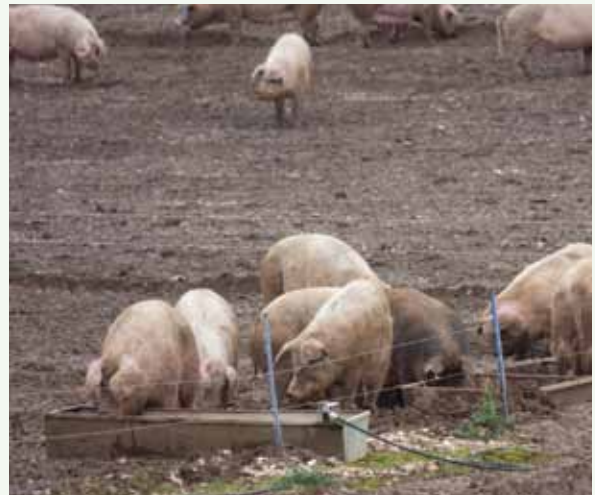
PIG-FARMING is an increasing presence in the valley. Unchecked the run-off from pig fields can be massive and it arrives at the river along roads and tracks and ditches.

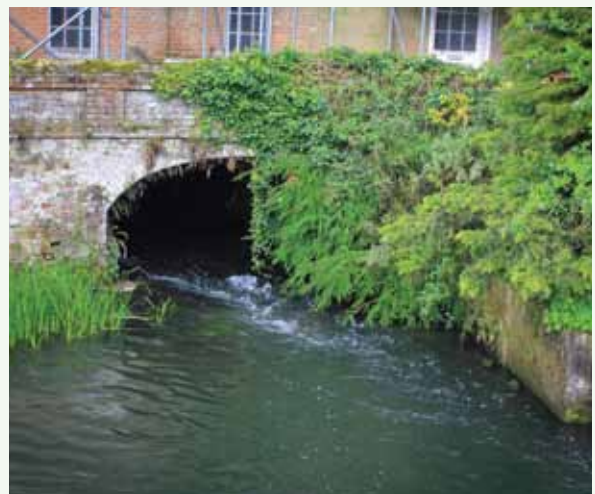
IMPOUNDMENTS are a major impediment to the ecological well being of the river: not only do they cause an accumulation of sediment in the impounded reaches, but they also impede the free passage of fish.

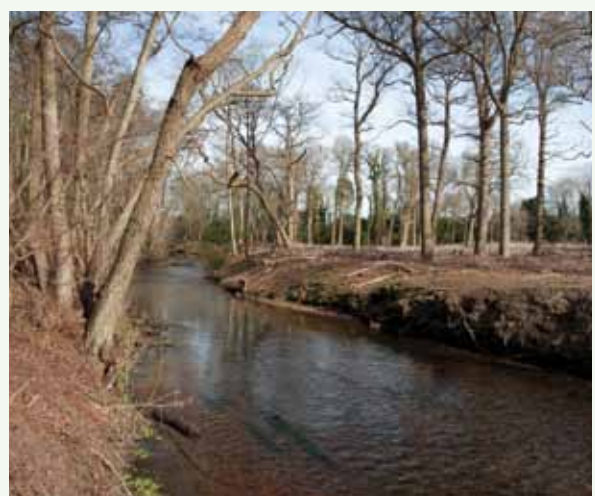
PLANTATION FORESTRY: the dense shade within plantation forestry leaves bare river banks vulnerable to erosion and devoid of cover for fish and insects.

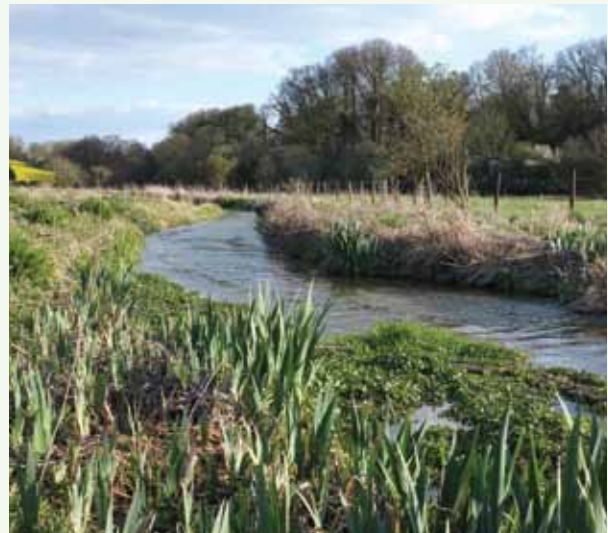
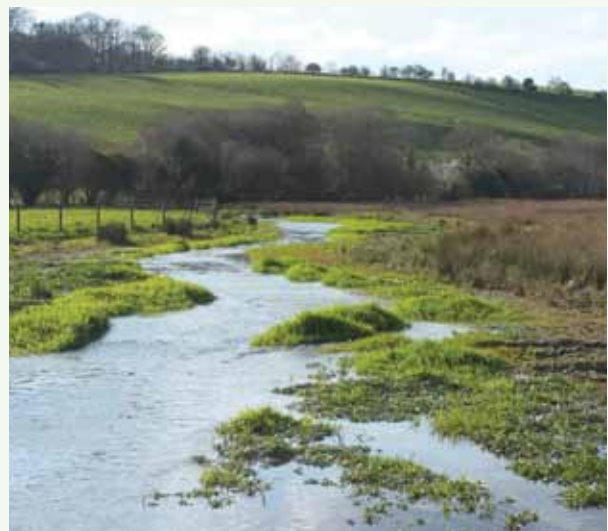
On an undredged reach of the Sydling Brook in Dorset (above and below) it is possible to see the interaction between a diverse community of plants in a shallow wetted, riparian margin and the dynamic, sinuous channel. Note these picture were taken in low flows and yet the river is close to bank level.

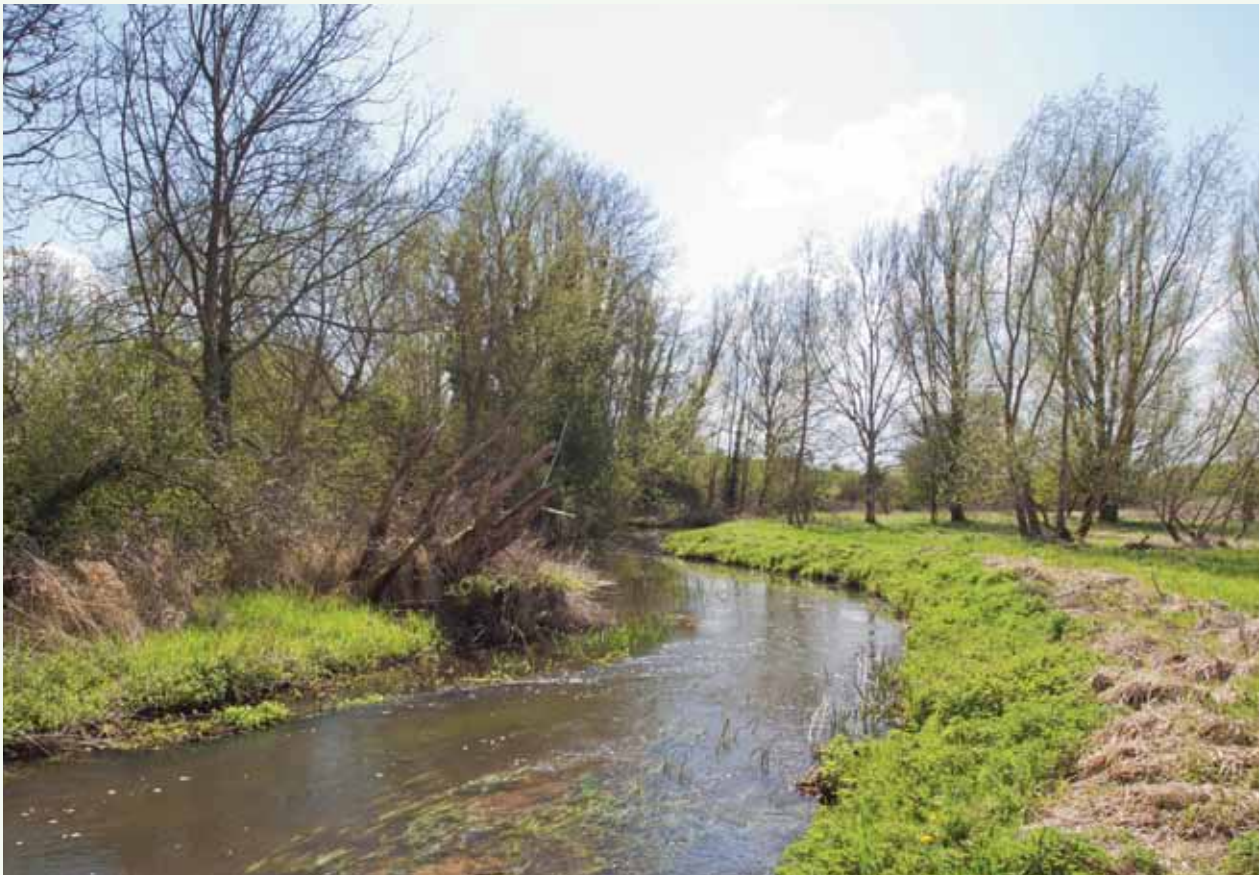
Connectivity is the underlying issue on the upper Nar. This reach (above) just outside Castle Acre is a good example of a part of the river that looks unmodified but which has, in fact, been dredged: the northern (right) bank is a levee formed by dredgings from the river. And again below the northern (left) bank is built high by dredgings. Even in flood – as illustrated in both photos – the channel is so incised that water is nowhere near the top of the bank.

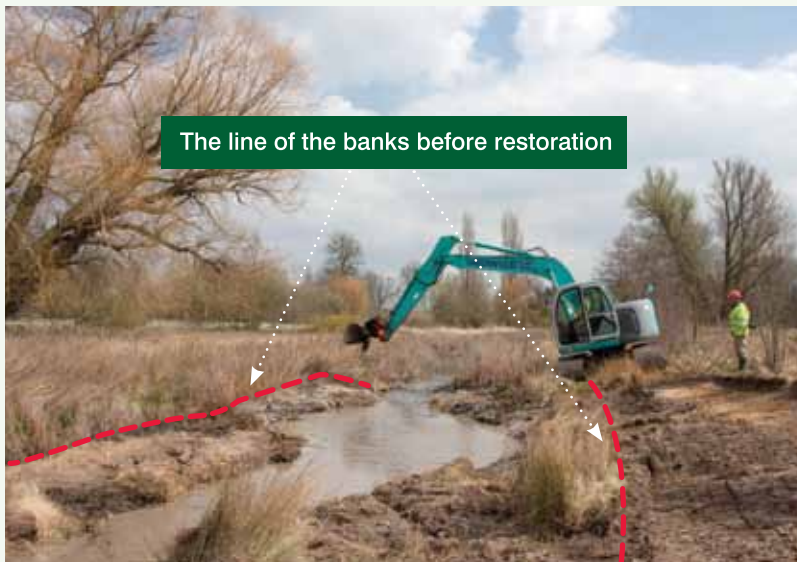
The line of the banks before restoration

RESTORING CONNECTIVITY
TAKING THE BANKS DOWN

The front edge of the new bank is planted up with plugs of reed canary grass. When the river rises in higher flows it will be able to spill over the margins and deposit silt on the bank edges and in the back eddies created by the uneven planform, while the main channel remains scoured and clean.

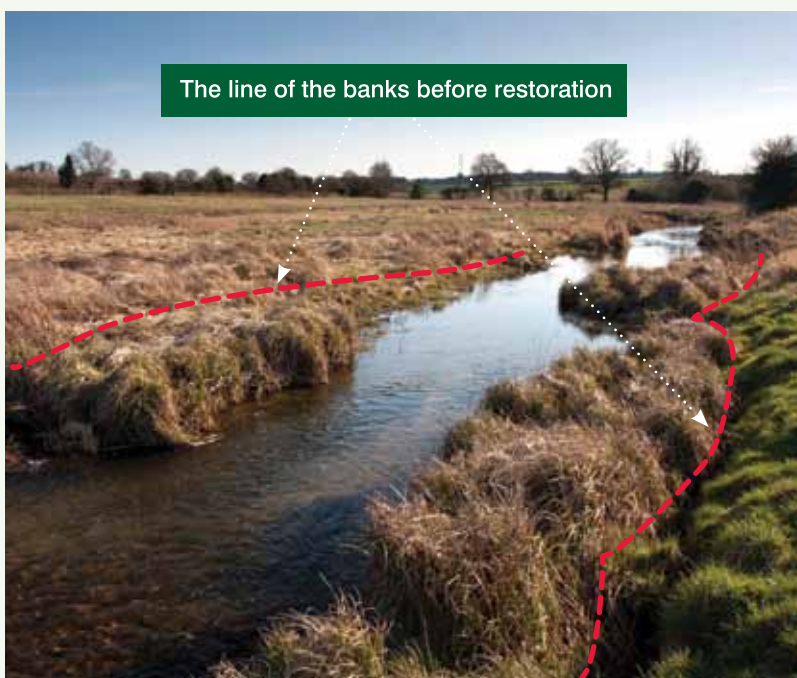
The line of the banks before restoration

RESTORING CONNECTIVITY
RE-SCULPTING WITHIN THE CHANNEL

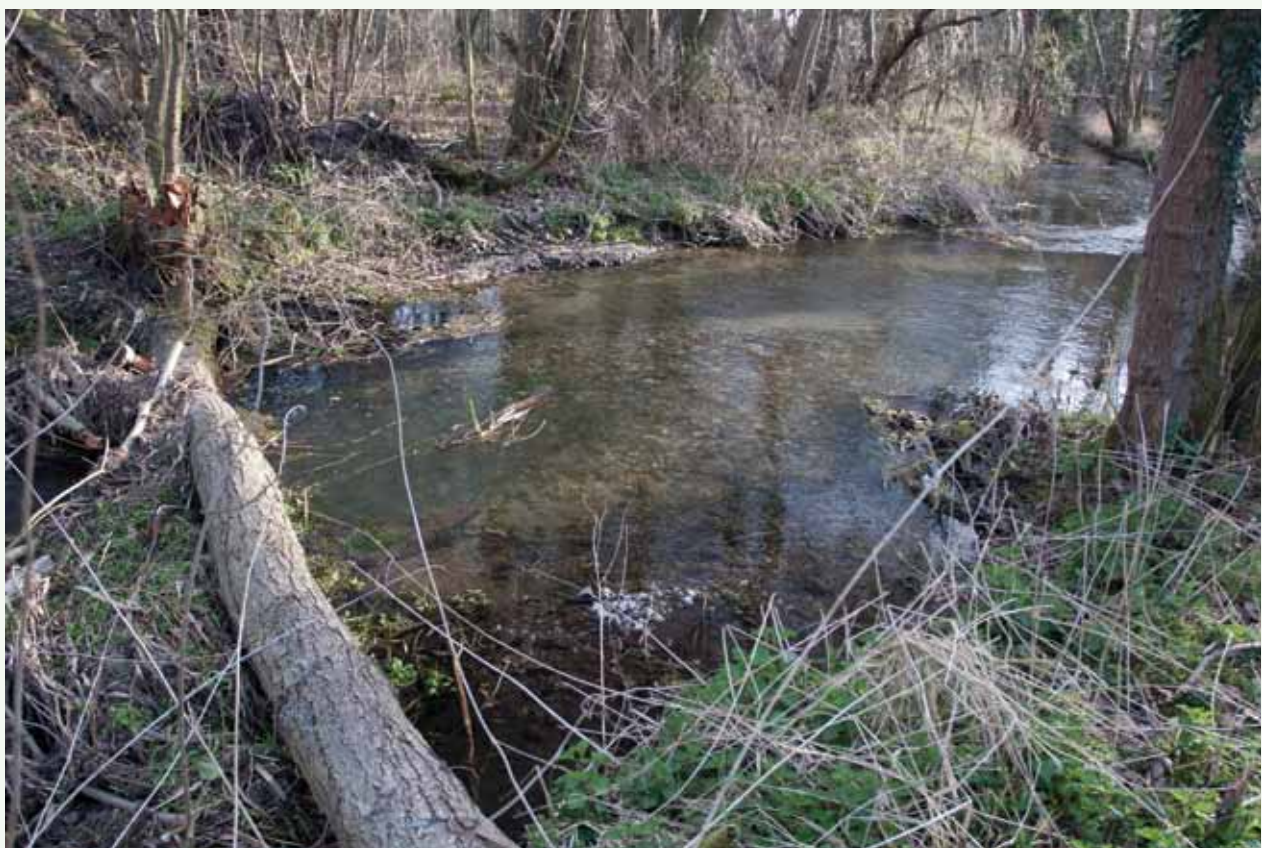
Already piloted on three reaches around Castle Acre. By sculpting pools and pinches in the river bed and 'planting' mats of vegetation either as shoulders pinching the flow, or as long berms which narrow the channel, it is possible to restore connectivity on a localised scale, immediately surrounding the river. On the upper section of Minn's Meadow the density of the work over 400 meters was such

that a berm of one sort or another was created on at least one bank along almost 100% of the channel length.

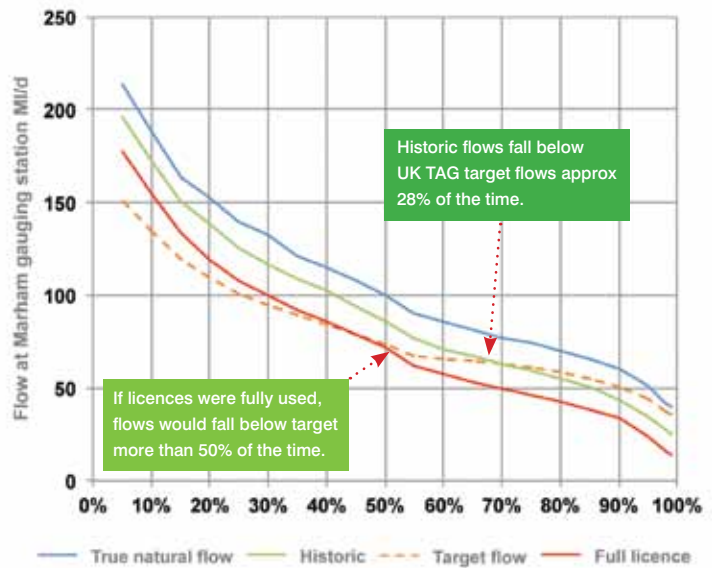
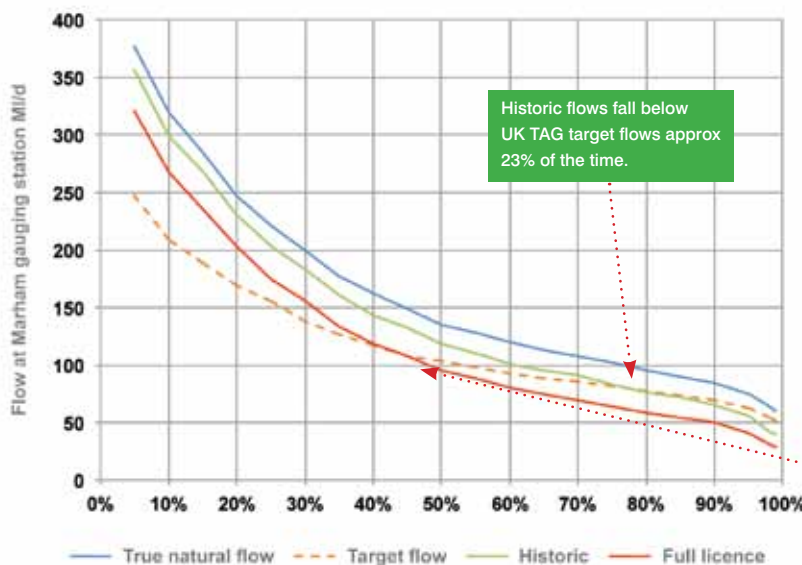
ABSTRACTION GRAPH 3 UPSTREAM OF NARBOROUGH

ABSTRACTION GRAPH 4 DOWNSTREAM OF NARBOROUGH

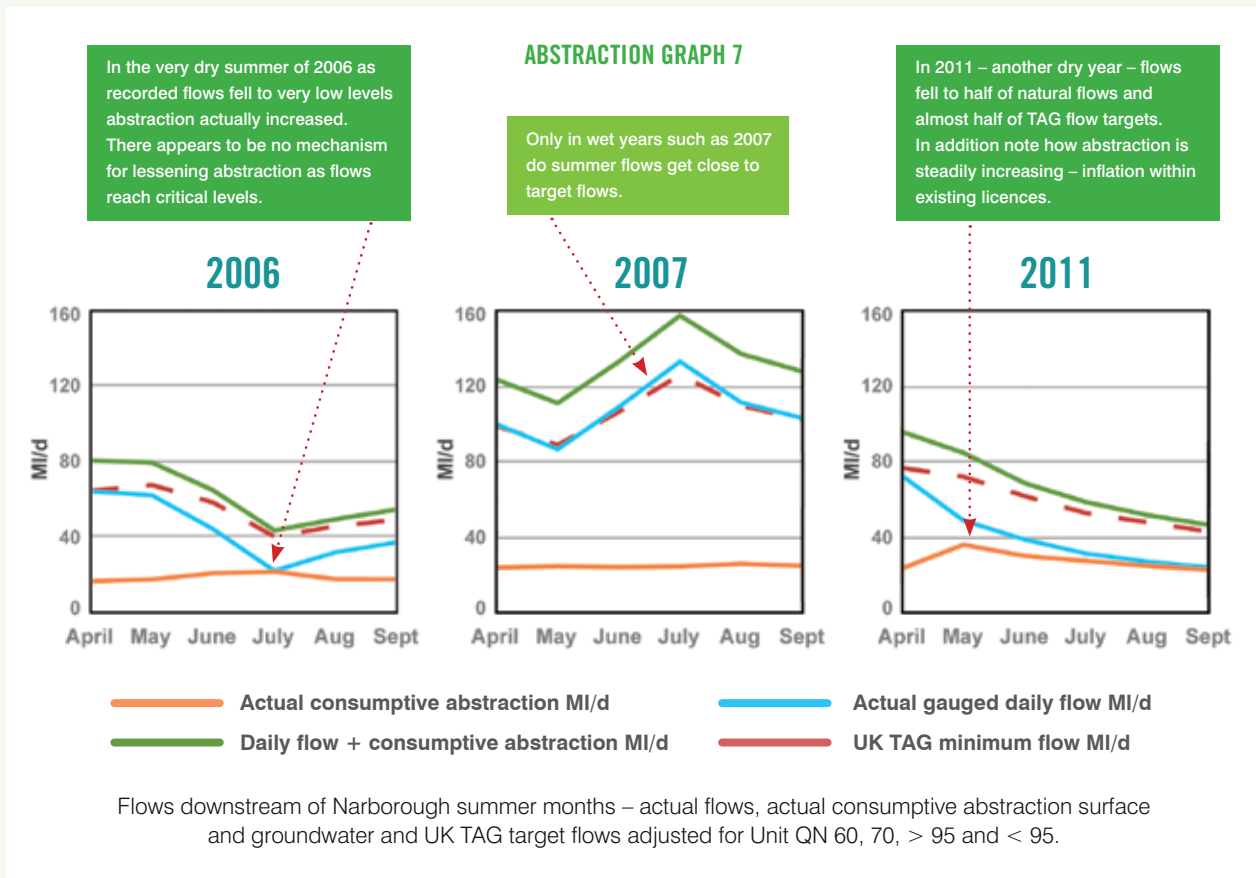
FLOWS IN RECENT YEARS

The flow charts above (Abstraction Graph 7) show the years 2006 and 2007 and also 2011. 2006 was a dry year. In July 2006 gauged flows dropped to 22 MI/d. As flows fell through May and June abstraction actually increased, to the point where abstraction peaked as the river flows bottomed out. There appears to have been no mechanism in place to restrict abstraction and help the river achieve target flows, in spite of the fact that the 2005 CAMS had already identified damaging levels of abstraction at low flows.

2011 was another dry year with real flows falling to half TAG target flows. Although there are “Hands Off” restrictions on some abstraction licences the quantity of water abstracted in summer is steadily increasing regardless of whether it is a dry or wet summer.

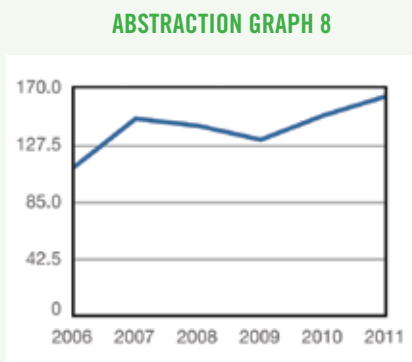
April to Sept totals of average daily consumptive abstraction for the years 2006 to 2011

Summer abstraction is steadily increasing. This amounts to inflation within the existing abstraction licences. Unless checked abstraction – already damaging the river – can keep on rising within existing licences with increasingly disastrous consequences for the River Nar.

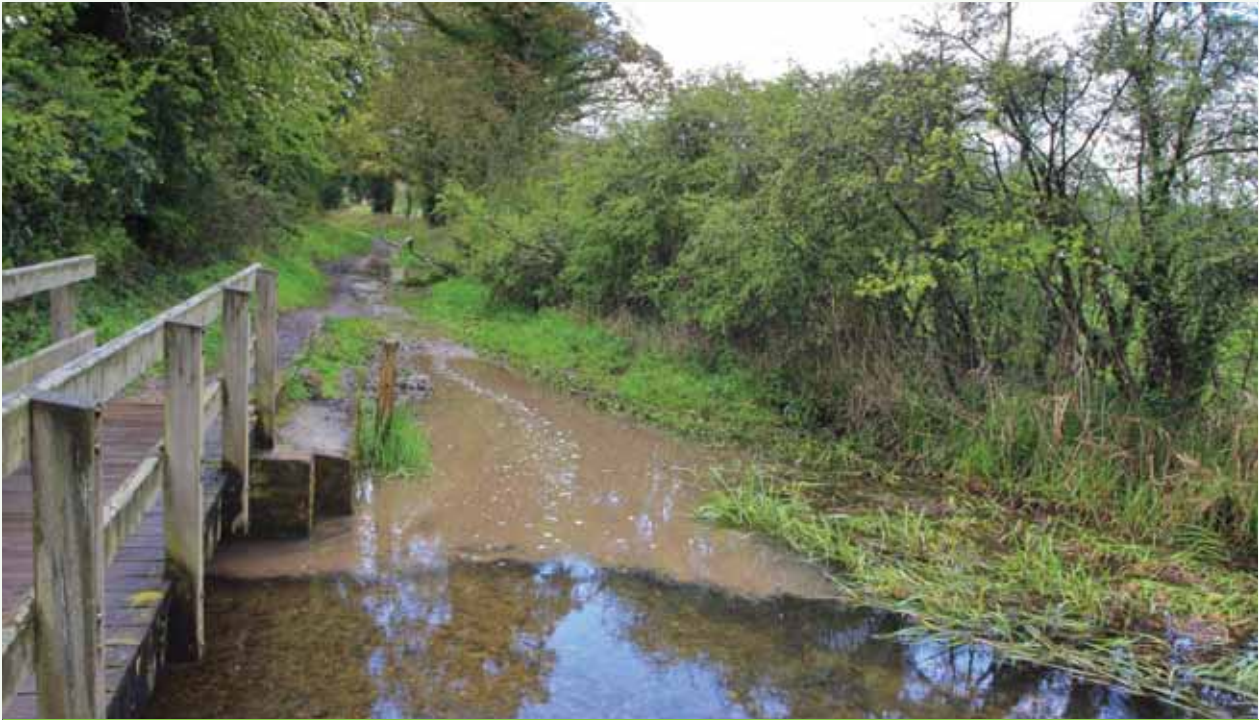
West Acre ford after a heavy downpour May 2012: a clear illustration of the impact of point-source sediment pollution. Diverting this flow into a wetland settlement pond in the meadow beside the river would make a big difference with the add-on ecological benefit of creating more wetland habitat.

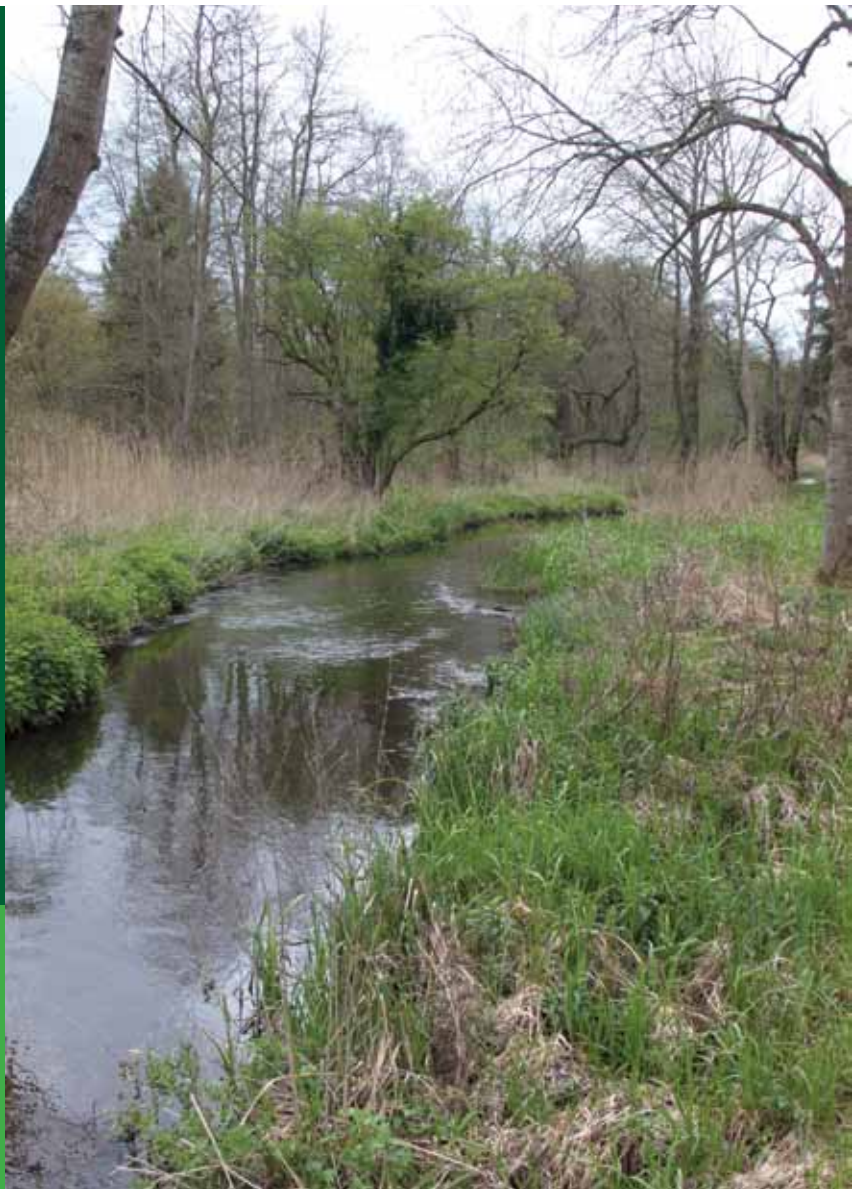
In a pilot restoration project carried out by the West Acre Fishing Club this reach has been selectively thinned to recreate a more extensive, natural woodland. All of the visible bank on the right hand side of the image has consolidated naturally on a mattress of woody debris.
